CASE STUDY #1685 | TORQUEPRO

INDUSTRIAL INSERTION

Brass fitting insertion into a plastic housing.
Torque testing brass connector within plastic housing to detect cracks.

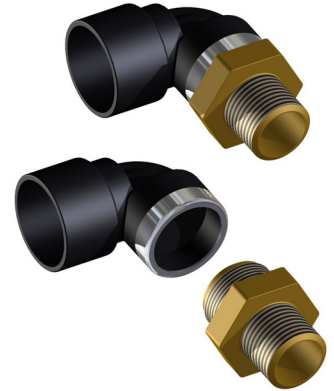
Upon insertion of brass fitting into the plastic housing, a certain percentage of the plastic pieces were cracking. This problem was partially fixed by adding a metallic ring around the opening to strengthen the plastic. Unfortunately this did not fix the problem entirely, and added some frustration to the process. Even though the amount of cracks were reduced, it was still happening. It could not be physically noticed due to the metallic ring covering up the evidence.

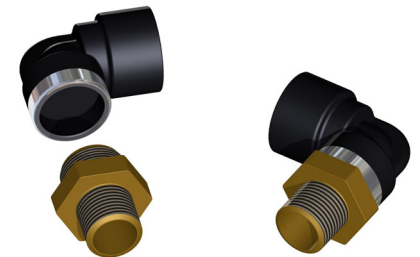
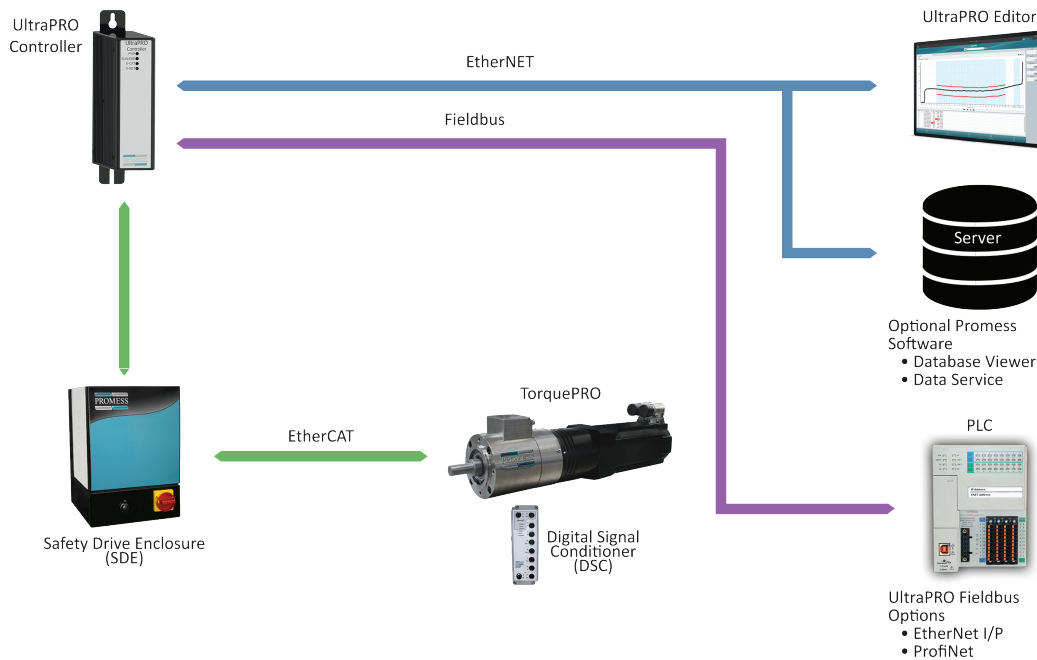
Using a Promess TorquePRO unit, the customer can do a 100% inspection of all parts by doing a revolution versus torque test. This gave the customer a precise graph of the test, allowing them to give an upper and lower limit of the good part taught. This confirmed if the part was cracked (torque too loose) or not. Another solution would be to use either a Promess Motion Controller or EMAP for insertion of the brass fitting into the plastic to detect cracking of the part.
